X-Ray of Alenia Parts

M. Gilchriese

May 1999

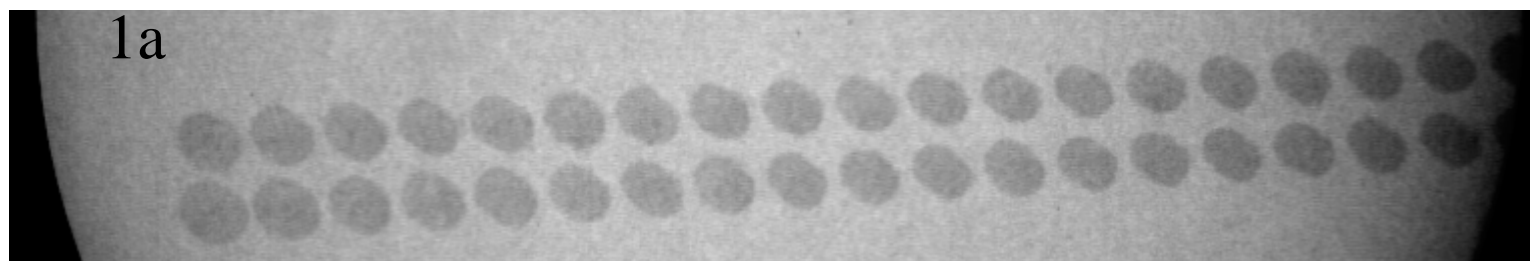
Near row 0
Close to merge

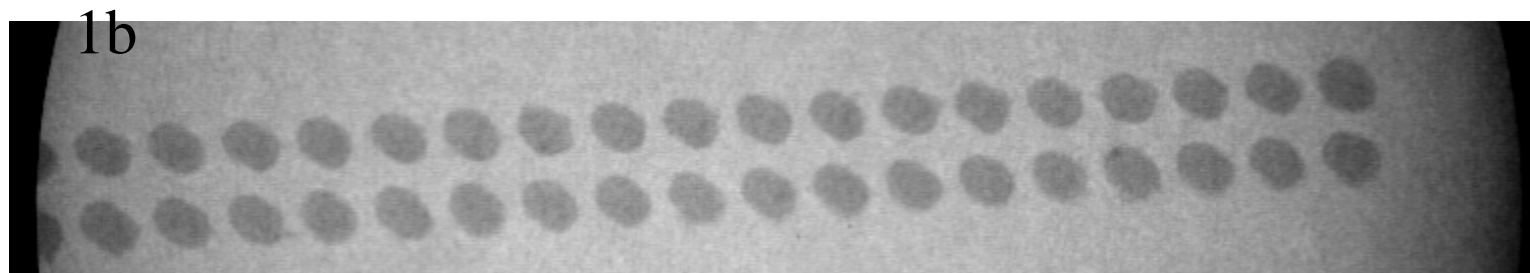
Same column
as above but
near row 160

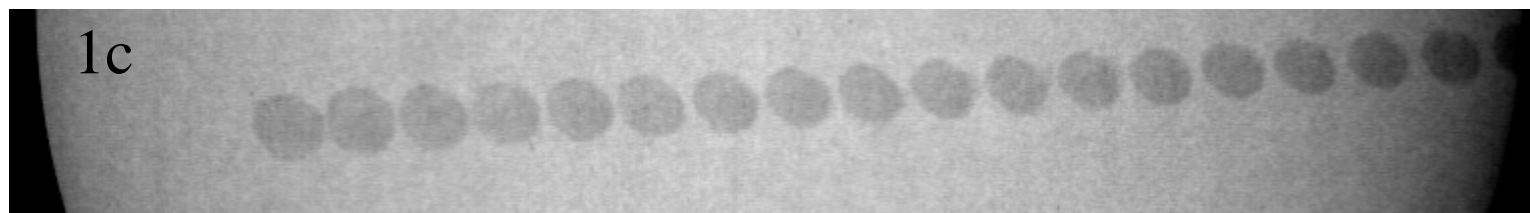
Row 0 near
edge, col. 17
Worst area
for possible
merged bumps

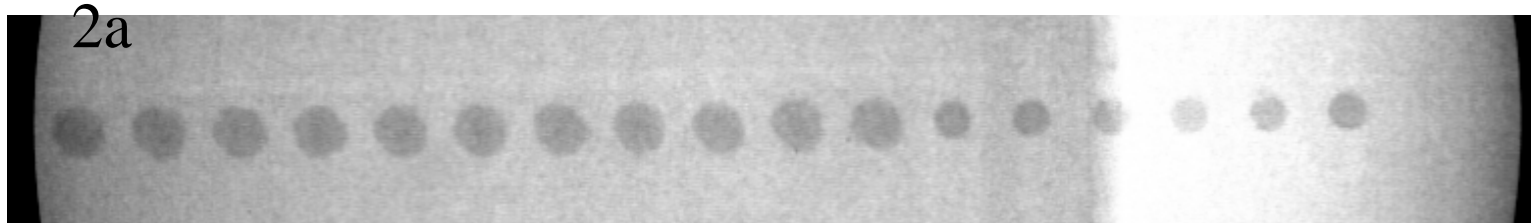
Col. 0 near
row 160. Is
this misplaced
or feature of
this detector?

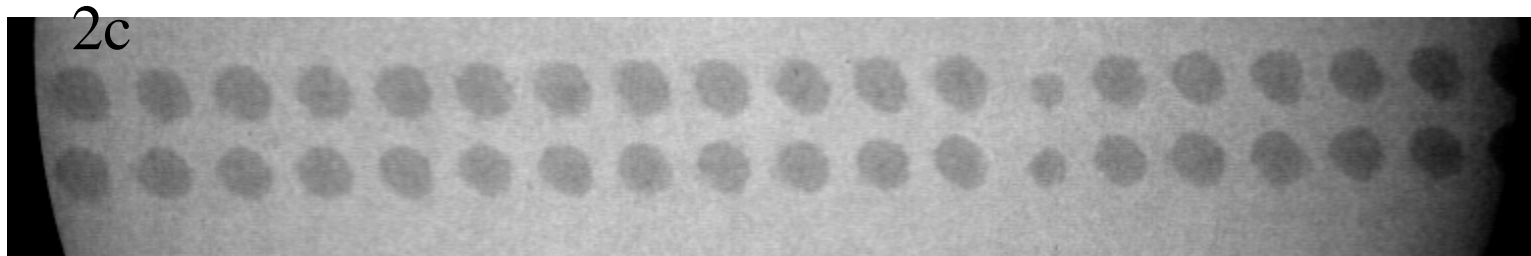
Col. 12-13 near
row 0. 2 missing
bumps

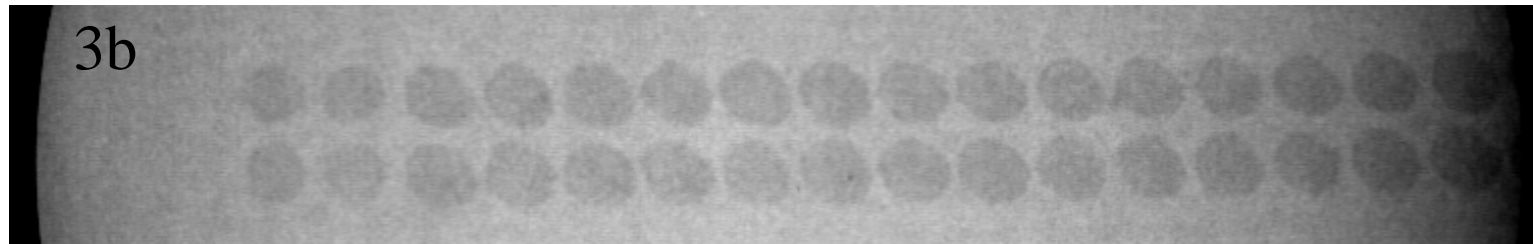
Col.15-16, near
row 0, close
to merged
